# The Oroville Dam 2017 Spillway Incident

And Lessons from the Feather River Basin

September  
2017

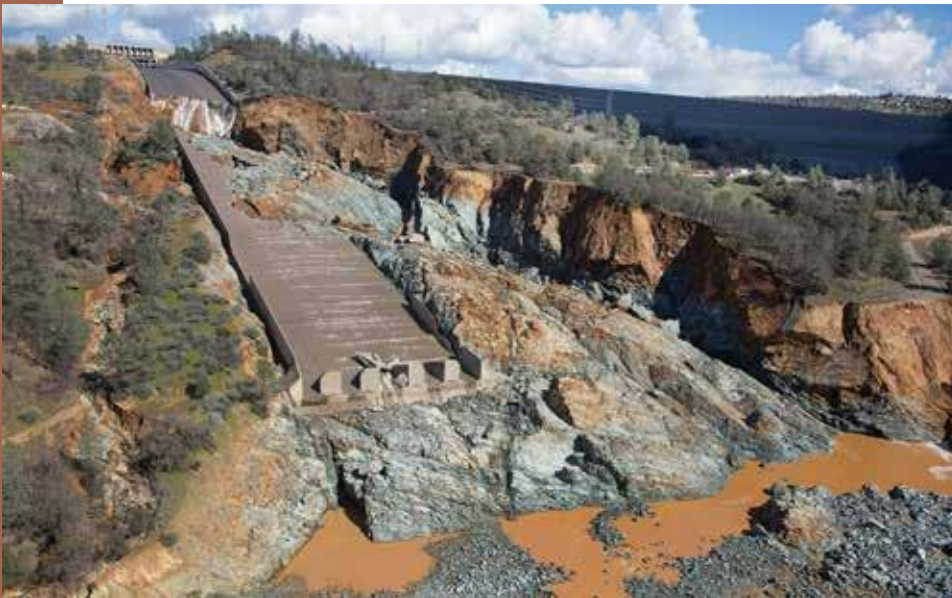
**Oroville Dam Spillway, Feb. 27, 2017.**

The Oroville dam main spillway after spill flow releases ceased for repair inspections. Oroville Dam is in the shadow on the upper right. *Source: Dale Kolke, CA Dept. of Water Resources (hereby DWR).*

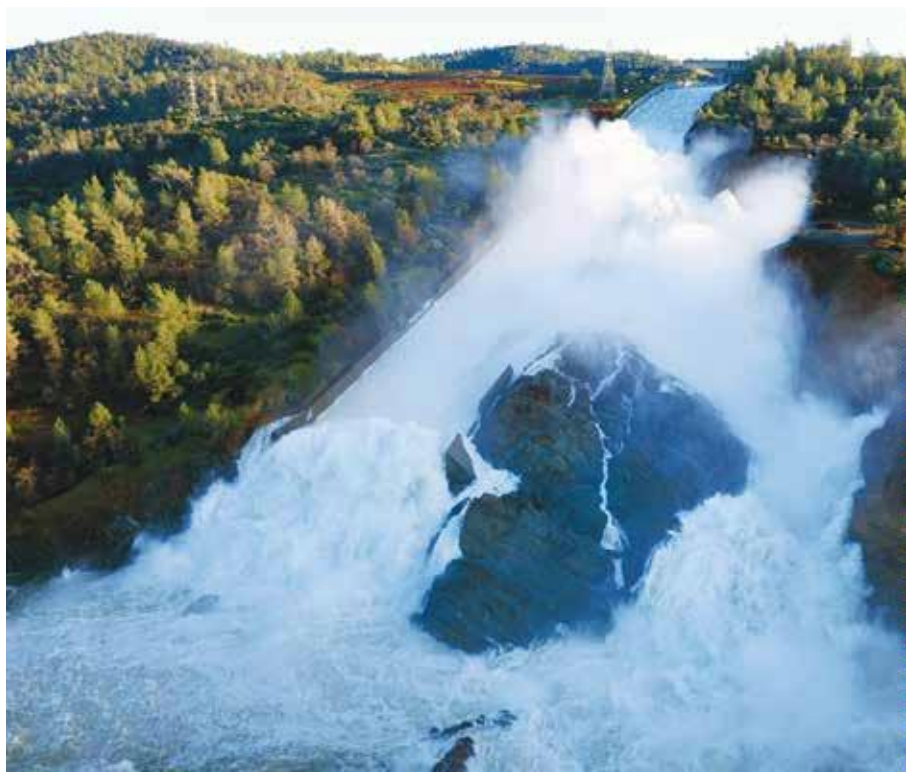
Aerial view from a DWR drone shows a 55,000 cfs release down the main spillway. Despite existing damage to the main spillway, these high flows were released as the reservoir level exceeded 901 ft elevation, and water spilled at 5,000 to 10,000 cfs over the Oroville emergency spillway.

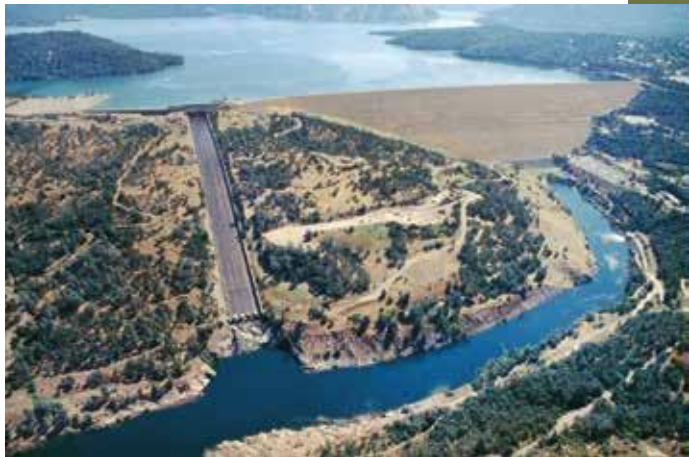
**Oroville Dam.** This aerial photograph was taken before 2017 and shows the dam on the right side, the concrete main spillway in the middle, and the emergency spillway on the left with a vegetated hillside below. *Source: DWR.*

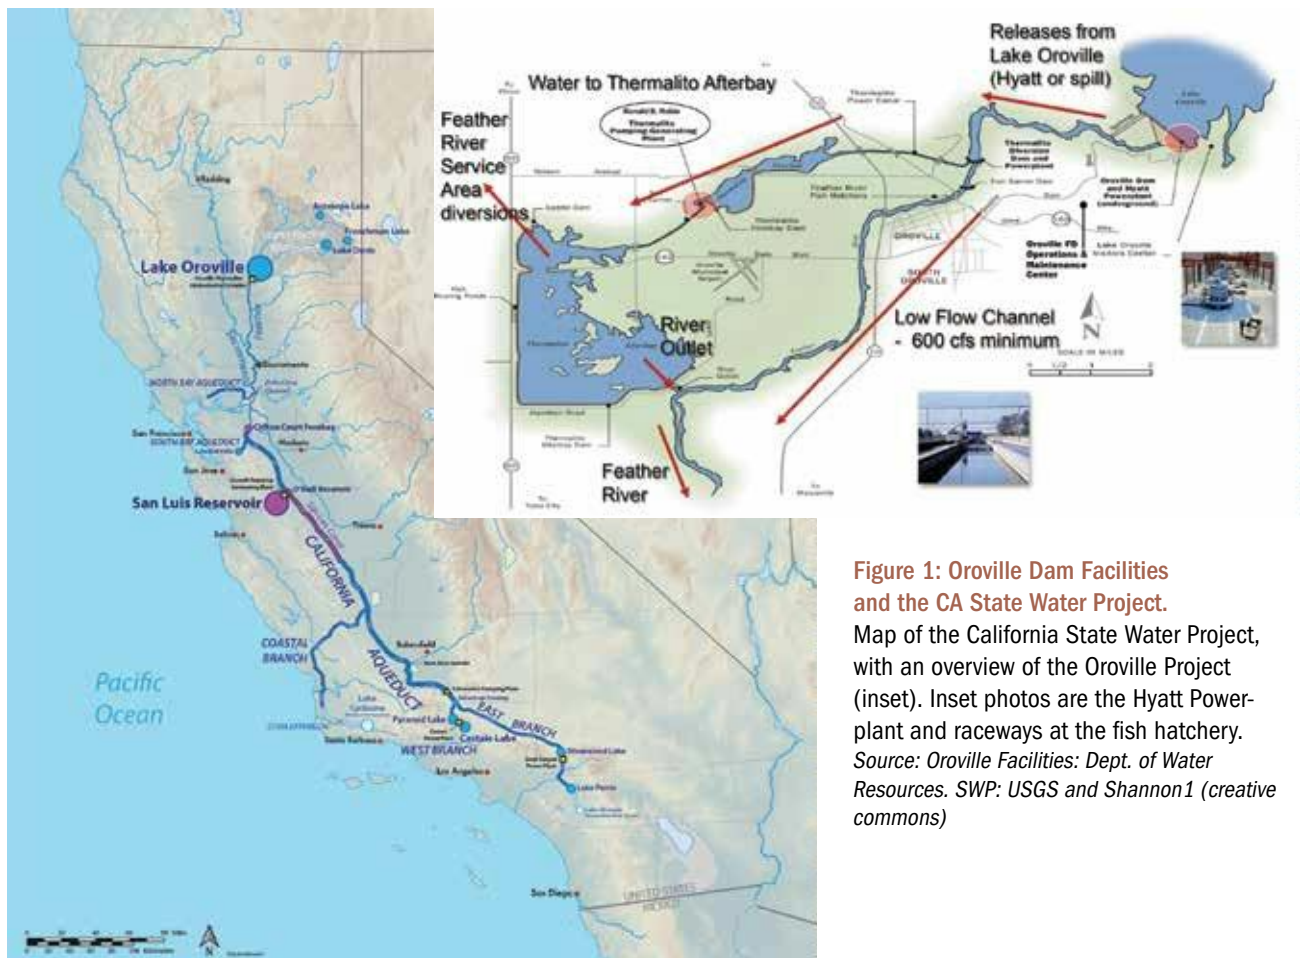
**Figure 1: Oroville Dam Facilities and the CA State Water Project.**

Map of the California State Water Project, with an overview of the Oroville Project (inset). Inset photos are the Hyatt Powerplant and raceways at the fish hatchery.

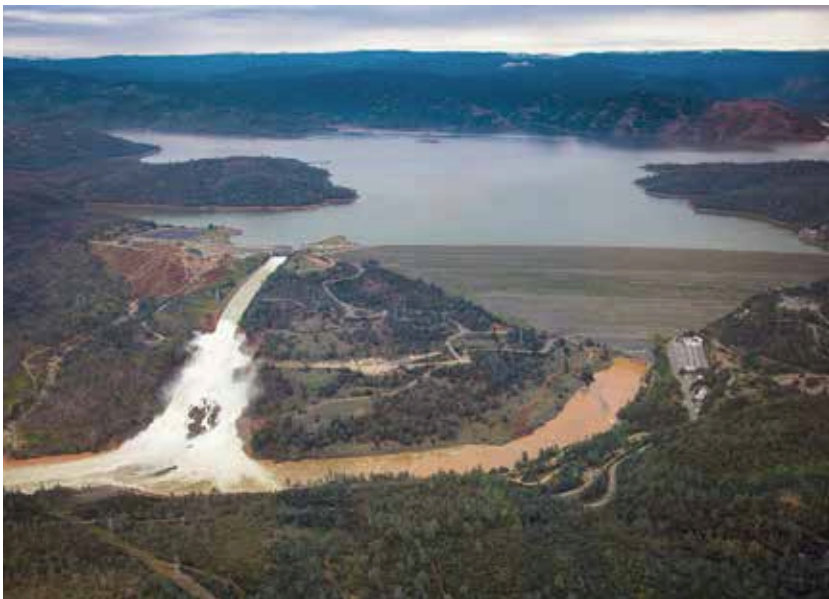
**Oroville Dam's Main Spillway at 100,000 cfs.** An aerial view looking eastward toward Oroville Dam and Reservoir. The emergency spillway is on the left (note eroded red dirt area) and the damaged main spillway left of center. Oroville Dam is on the right. An outflow of 100,000 cfs travelled down the main spillway on Feb. 15, 2017. Source: Dale Kolke, DWR.

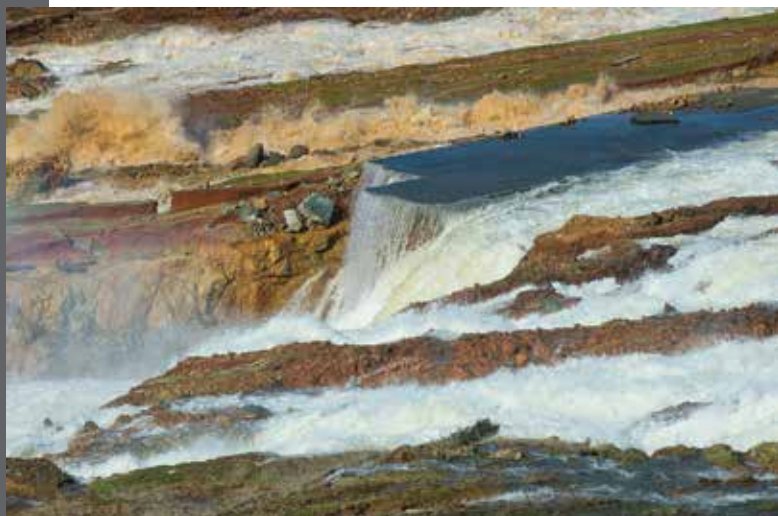
**Emergency Spillway Flows and Erosion.** Water flows over the Emergency Spillway for the first time on Feb. 12, 2017, eroding gullies and destroying a roadway. Source: Kelly M. Grow, DWR.

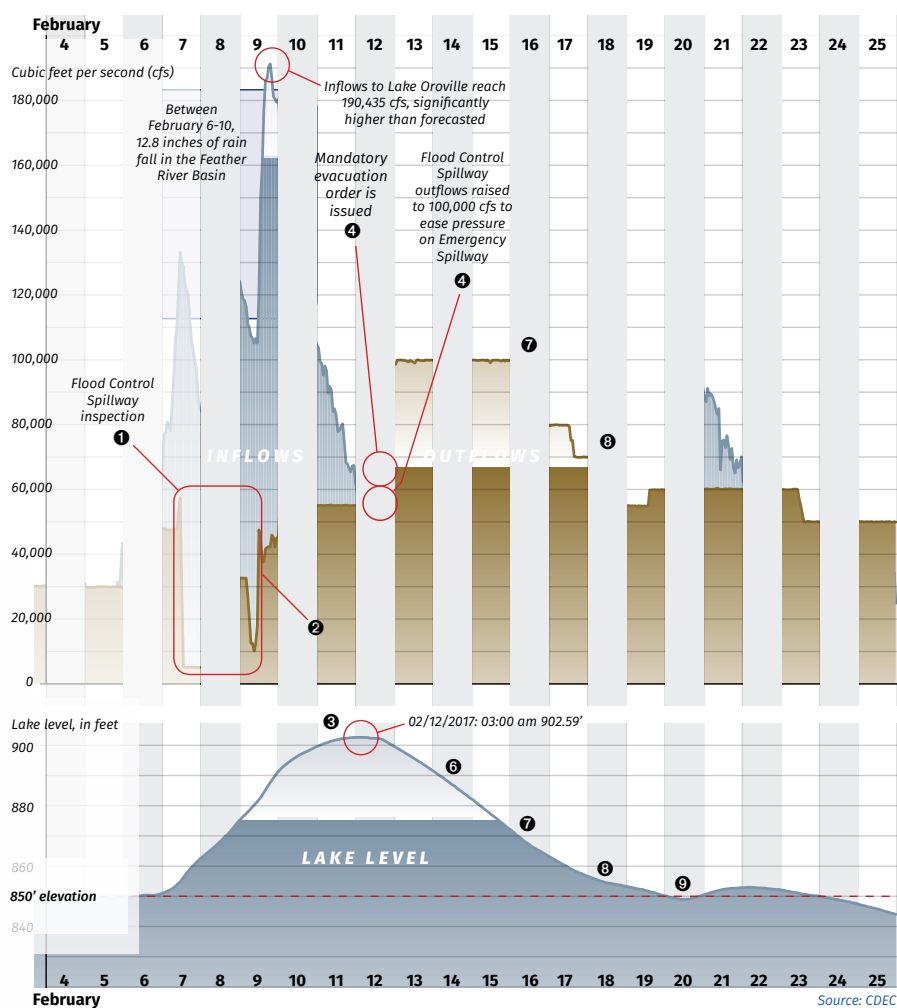
## Oroville Spillway Timeline - February 2017

**February 7:** Reservoir inflows exceed 130,000 cfs, and main spillway releases peak at 54,500 cfs. Unusual flow pattern observed. Releases are stopped, and a large crater/hole is observed. (1)

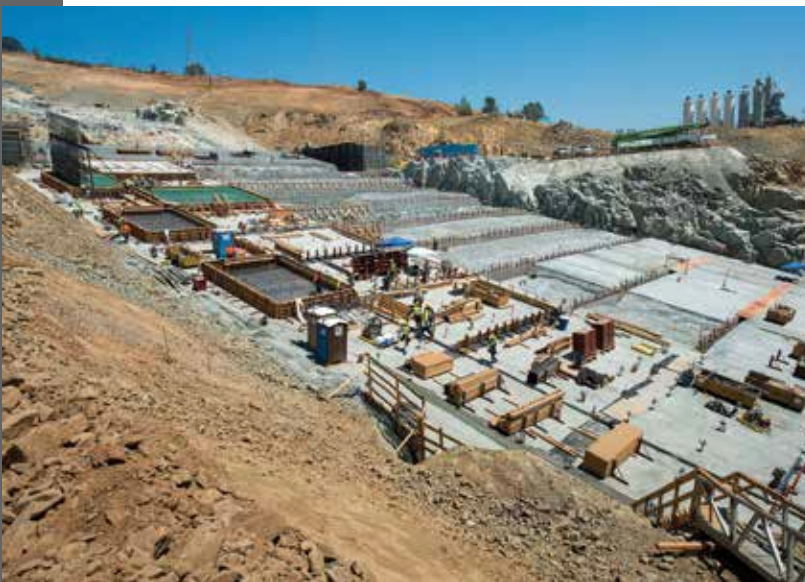
**Oroville Dam Main Spillway Repair.** Image date: August 9, 2017.  
Source: Florence Low, DWR.

By late spring, the reconstruction began in earnest, with the goal of reconstructing the lower main spillway and its foundations and making smaller repairs to the upper spillway during the 2017 construction season. The plan for the emergency spillway is to build a cutoff wall by November 1 that would be located downhill on the hilltop to prevent headcutting, if used. At a later time, the spillway lip would receive a roller-compacted-concrete buttress and a “splash pad” (or “apron”).<sup>63</sup> Transmission towers and powerlines are being relocated out of harm’s way.<sup>64</sup>

The reconstruction plans are dynamic, apparently responding to conditions encountered as construction proceeds. The 2018 schedule may include reconstruction of the upper main spillway and the work described above immediately below the emergency spillway.

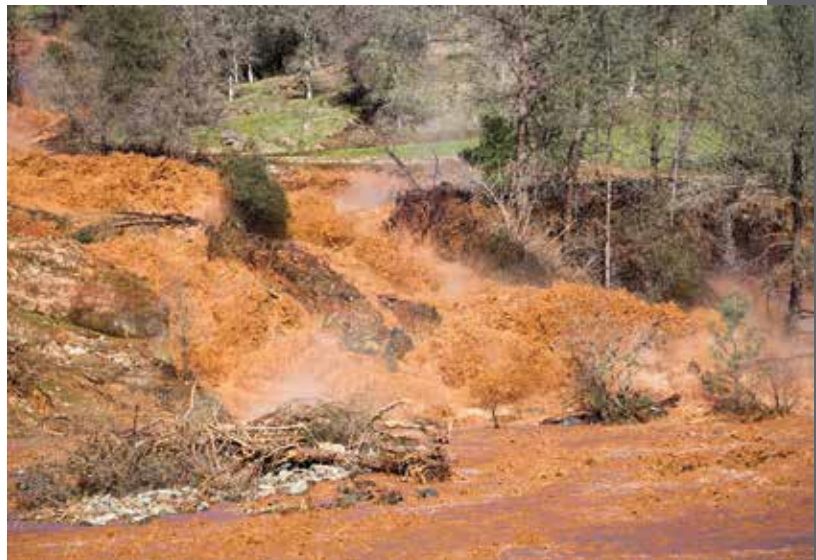
**Oroville Dam Spillway Erosion, Feb. 11, 2017.** Water and debris from the emergency spillway failure flow into the diversion pool just downstream of the dam. Source: Dale Kolke, DWR.

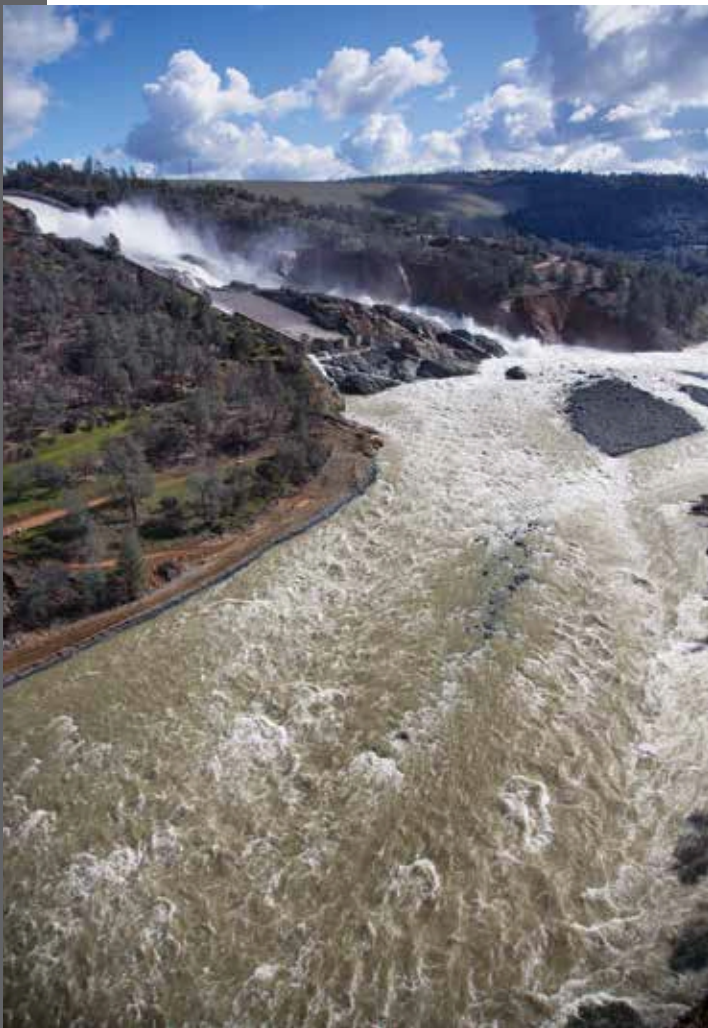
An aerial view of the diversion pool on the Feather River as outflow from the damaged Oroville Dam spillway was being reduced from 50,000 cubic feet per second (cfs) to zero on February 27, 2017. Source: Dale Kolke / California Department of Water Resources

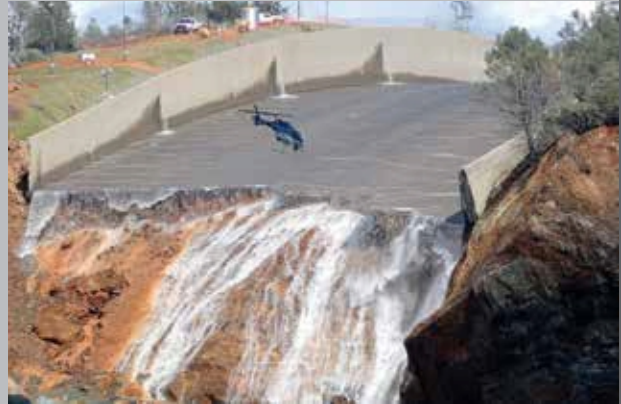
**Main Spillway, Feb. 27, 2017.** As DWR decreases flows on the damaged main spillway to assess damages.  
*Source: Bill Husa, Chico Enterprise-Record.*

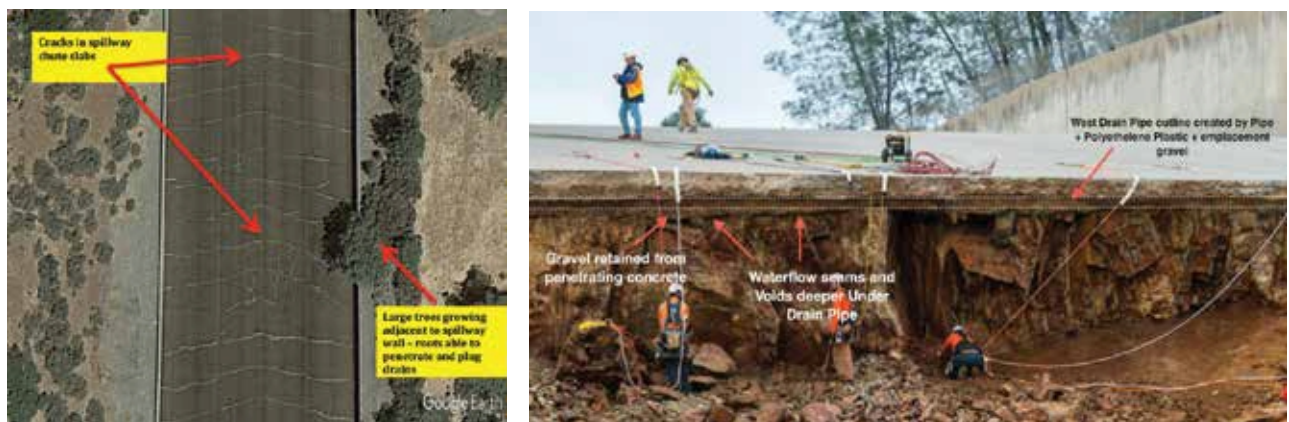
**Oroville Forensics.** Bea points out the many cracks on the surface of the spillway, as well as trees growing too close to the edge of the structure in this 2010 satellite image (left). Bea believes a hidden drain pipe proved the critical weakness along the spillway (right). Image source: Bea, *Root Causes Analysis*, using GoogleEarthPro and DWR images.

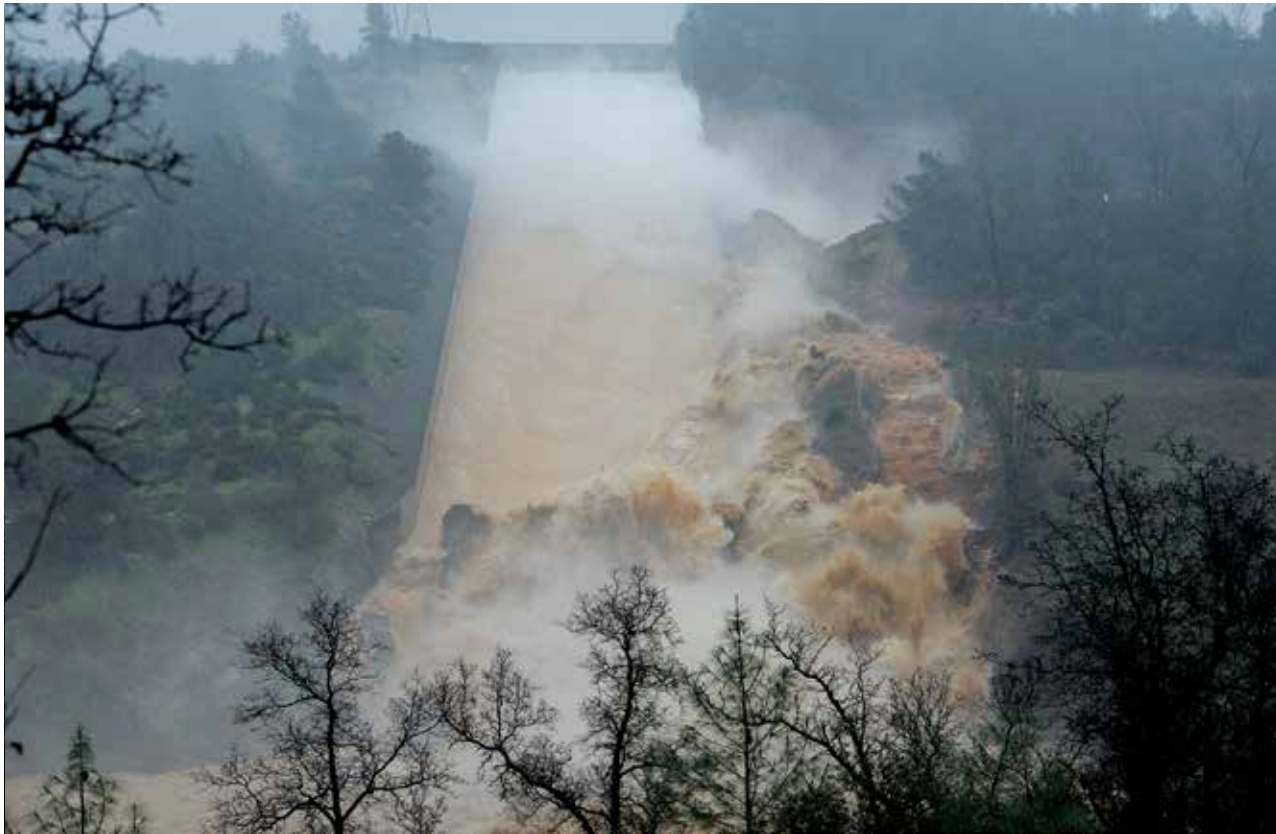
**The Oroville Incident, Feb. 2017.** As the Oroville Reservoir main spillway crumbles, mud, rocks and concrete flow in to the Feather River on February 8, 2017. Source: Bill Husa, *Chico Enterprise-Record*.

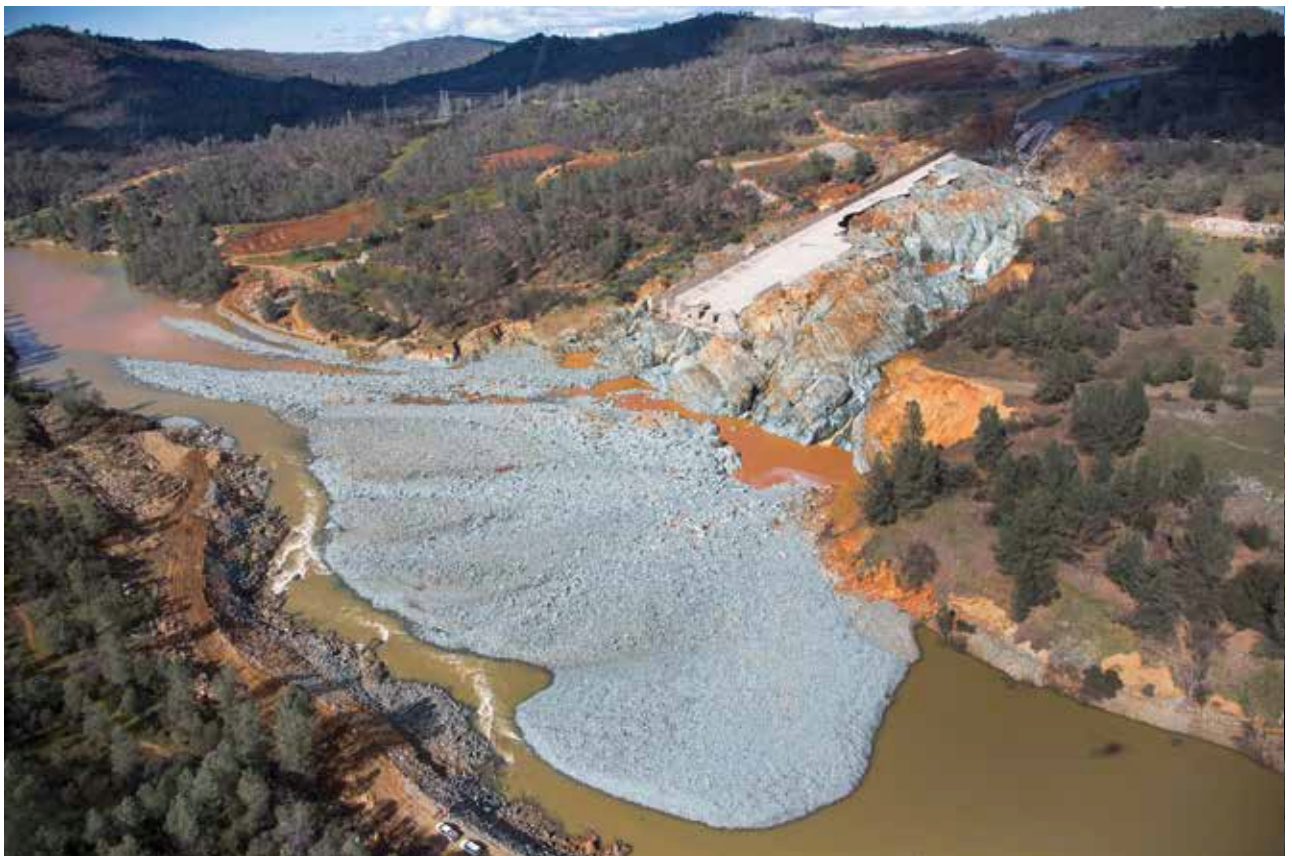
**Damaged Main Spillway, Feb. 27, 2017.** An aerial view of the damaged main spillway and resulting debris field. Flows were reduced from 50,000 cfs to zero on Feb. 27 to allow reduction of the water elevation in the diversion pool, removal of debris, and re-initiation of power generation at the Edward Hyatt powerhouse. *Source: Dale Kolke, DWR.*

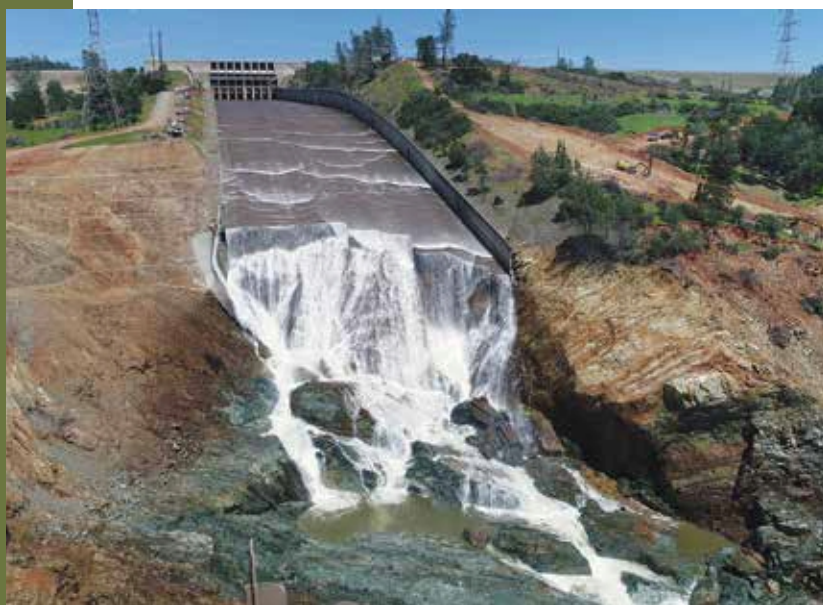
insufficient anchoring) go back to initial design and construction choices. And yet many of these problems tend to get worse with time. Maintenance issues, such as incomplete repair of concrete cracks, can increase vulnerabilities of the concrete to cavitation and can allow spillway flows to reach erodible foundations below the spillway.

**Main Spillway Erosion:** A view of the erosion cavity at the Oroville main spillway – an infrastructural failure combining design, construction and maintenance issues. May 1, 2017. Source: Mike Burns, DWR.

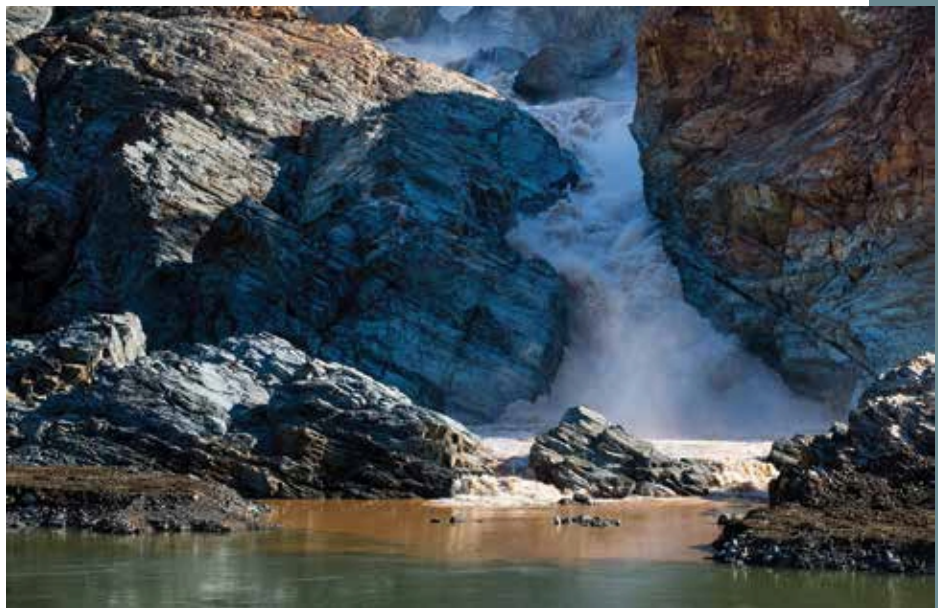
Flows leaving the damaged Oroville Main Spillway enter the diversion pool of the Feather River, April 14, 2017. Source: Kelly M. Grow, DWR.

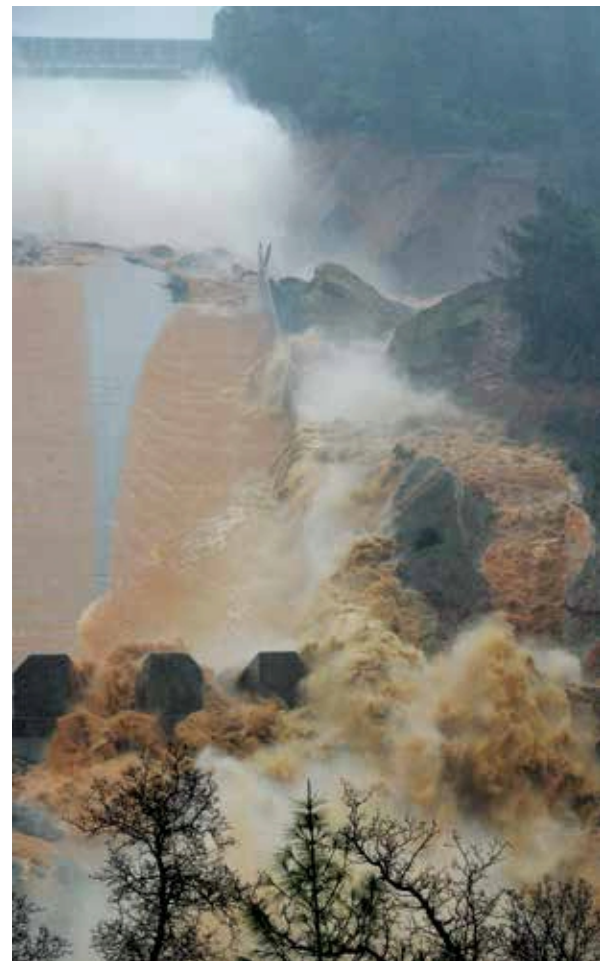
**Damaged Oroville Main Spillway.**  
Mud and debris tumble down the newly eroded channel alongside the Oroville main spillway on Feb. 8, 2017.  
Source: Bill Husa, Chico Enterprise-Record.
